## **Summary of EPA Surface Water Sampling Results to Date**

### **Gold King Mine Blowout**

Updated August 7, 2015

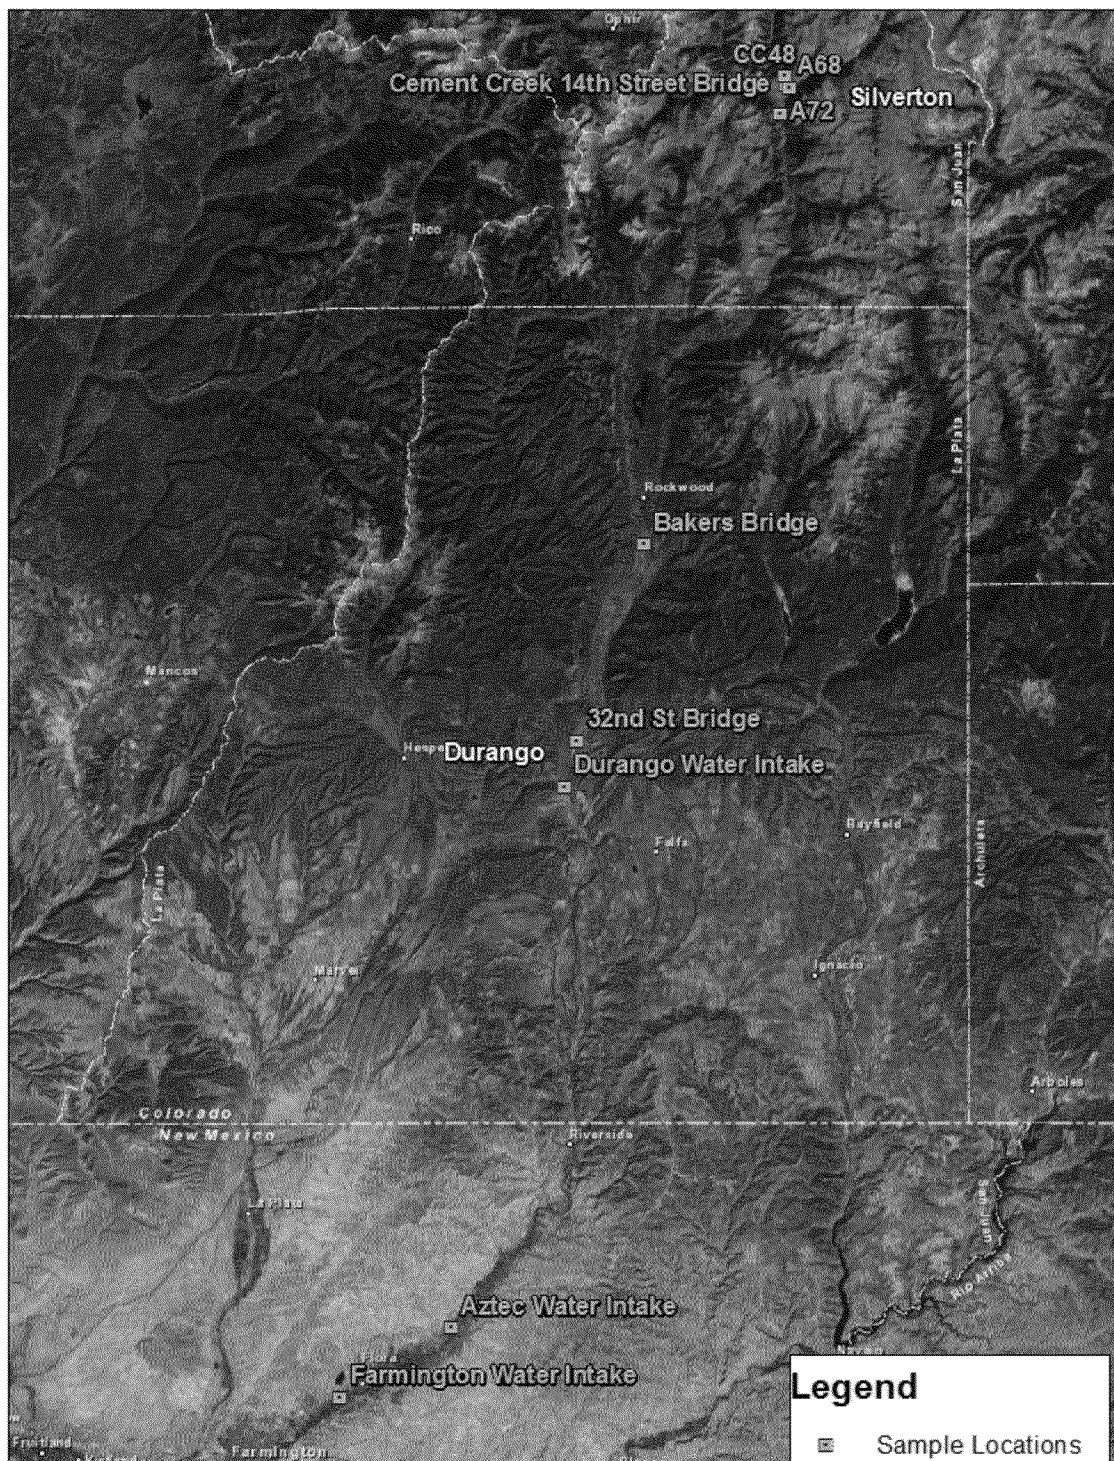
### **Attachment 1: EPA Sampling Locations**

EPA initiated a sampling effort on August 5, 2015, to assess the impacts of the blowout at the Gold King Mine near Silverton, CO. Surface water quality samples were collected from 9 locations (see Attachment 1). Two of these locations were on Cement Creek and 7 of these were on the Animas River. These locations were selected based on the fact that an historical dataset already exists at these locations and they will serve thus as good indicators of conditions before, during and after the event.

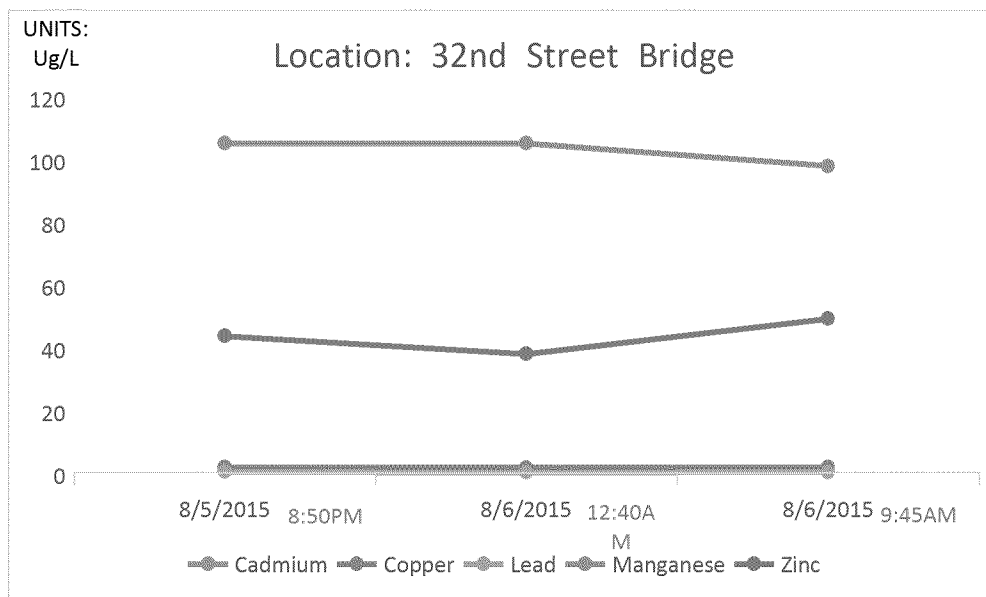
The fifth graph is of the 32<sup>nd</sup> Street Bridge sampling location. At the time the samples were collected, it does not appear that the contamination had yet reached this sampling location. It is believed that subsequent data collection activities will demonstrate an increase in metals concentrations followed by a decrease to baseline.
